Critical beaches due to coastal erosion in the Caribbean south of Costa Rica, during the period 2005-2016

*Gustavo Barrantes-Castillo*¹
*Isabel Arozarena-Llopis*²
*Luis Fernando Sandoval-Murillo*³
*José Francisco Valverde-Calderón*⁴
Universidad Nacional, Costa Rica

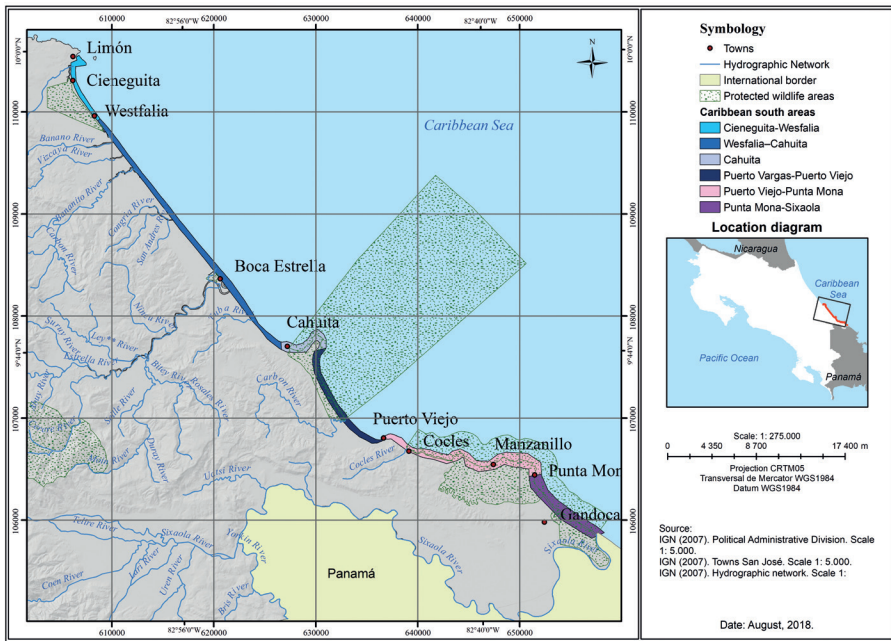
Figure 2. Beach erosion study areas in the Costa Rican Caribbean south.

To facilitate the interpretation of the obtained results, the study area was divided into six sectors according to the configuration of the coast (Figure 2), namely:

- **Cieneguita-Westfalia:** sector located at the northwest end, characterized by possessing an extensive beach with a slight concavity pointing north opening to the Caribbean Sea, mainly in the sector closest to the rocky promontory where the city of Limón is located. Cieneguita Beach has a jetty approaching the middle of the beach.

- **Westfalia-Cahuita:** this sector appears as a rectilinear coast having in its surrounding the presence of the mouths of important fluvial systems and wetlands (estuaries).

- **Cahuita:** small peninsular sector having two sections where the rocky reef platform is interspersed by a sandy beach (Cahuitas's Blanca Beach); on the smallest section of the platform sits the town bearing the same name (Spanish "Playa Blanca"), and on the other a section of land called Punta Cahuita. Both Blanca Beach and Punta Cahuita are part of a wildlife protected area (Cahuita National Park). Among the current main features of the park is the presence of an important coral reef.

- **Puerto Vargas-Puerto Viejo:** this corresponds to a straight to slightly concave shoreline sector spanning from the old berth town of Puerto Vargas to the town of Puerto Viejo; shoreline concavity opening to the Caribbean Sea. The continuity of this shoreline is only interrupted by the mouth of the Carbón River.

- **Puerto Viejo-Punta Mona:** this sector is comprised of relatively short and pocket beaches interspersed with ledges, rocky promontories and outcrops of the Pleistocene reef formations in the form of terraces.
- **Punta Mona-Sixaola:** rectilinear shoreline interrupted by ancient estuaries and wetlands; only the initial section of Punta Mona is rocky. It ends at the southern tip of Costa Rica, at the mouth of the Sixaola River which serves as the Costa Rica-Panama international border.

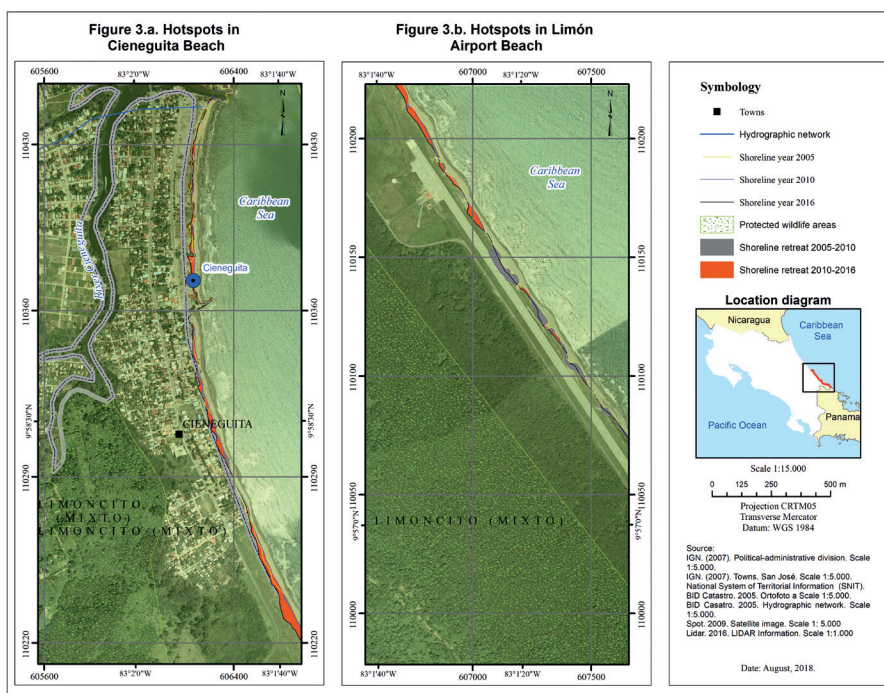
Figure 3.a. Hotspots in Cieneguita Beach.
Figure 3.b. Hotspots in Limón Airport Beach.

In the northern section of this sector is an urbanized area called Barrio Cieneguita, officially called the Cristóbal Colón sector, and to the south, the Limón Airport (Figure 3.b). The Cieneguita-Westfalia sector is

The sector between the jetty and the airport runway is considered an erosion hotspot registering a retreat rate of 1,430 m²/year for the 2005-2010 period and 3,936 m²/year for 2010-2016. According to these data, the retreat rate almost tripled in the second period (Figure 3.a). The above points to an apparent erosion process indeed confirmed by field inspection, during which it was also evidenced the resulting deterioration of public infrastructure and the ongoing maintenance works to contain further down-grade by placement of stones and wire meshing (Figures 4 and 5).

Another erosion hotspot is near the airport (Figure 3.b). For the period 2005-2010, the erosion rate of this sector was 8,801 m²/year and, for the period 2010-2016, it decreased to 1,599 m²/year. To the south of the airport there is a wetland characterized by the presence of small elongated lakes interconnected by channels that drain before reaching the town of Westfalia, thus suggesting an alteration of part of the Cieneguita wetland. The erosion of the beach has affected the asphalt layer of the runway; for its protection, rock and wire mesh covering has been installed (Figure 6).

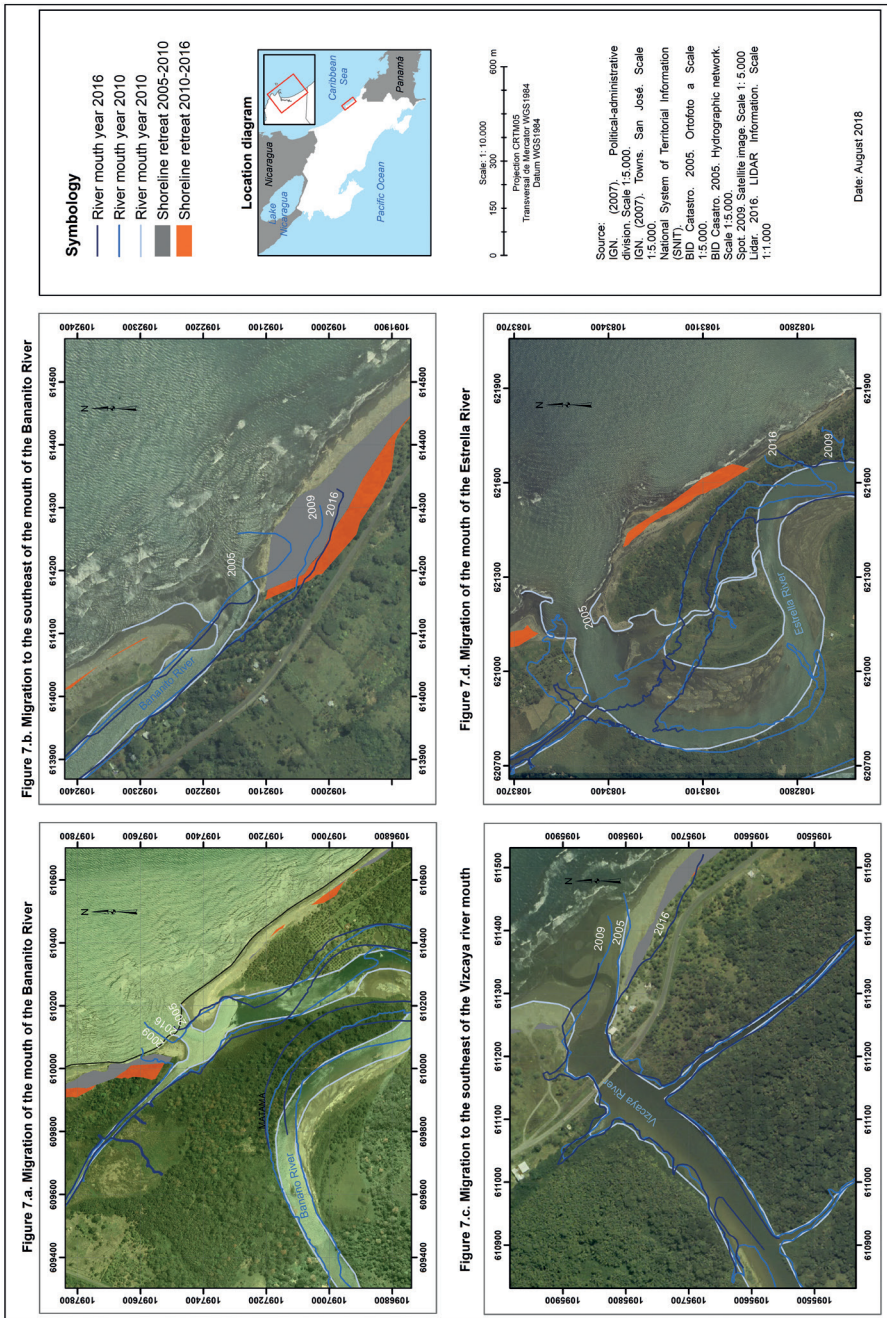
Figure 7. Coastal erosion and migration of river mouths in the Westfalia-Cahuita sector

This is a sector with extensive beaches interspersed with the mouths of important river systems (Figure 2). The littoral dynamic manifests itself in drastic changes in the shape of the shoreline, mainly due to the migration of the mouths. In this sector, the changes in the mouth of the Banano River stand out (Figure 7.a, top left) as causing the local retreat of the shoreline associated with the erosion of the left margin of the mouth and the accumulation of sediments on the right margin. Other river mouths causing significant shoreline changes are those of the Vizcaya River, Bananito River and La Estrella River (Figure 7.b, 7.c and 7.d, respectively).

Another critical point of erosion was located at the mouth of the Bananito River (Figure 7.a) where, as in the previous cases, it is related to the migration of the river course. In this case, the proximity of the shoreline with the road threatens the integrity of the main road that gives access to the rest of the region (figure 9). The erosion rate at this point is 2,817 m²/year in the period 2005-2010 and 2,793 m²/year between 2010-2016, which indicates that the rate remains similar between the two periods.

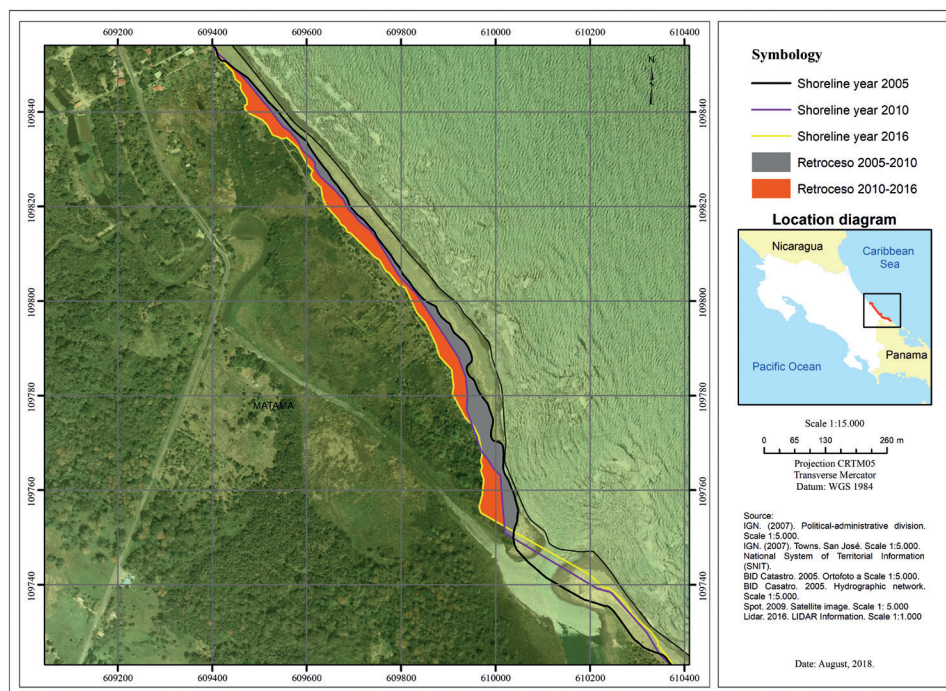
Figure 8. Hotspot located south of the town of Westfalia.

The first hotspot in this sector is located south of the town of Westfalia and is associated with the migration of the mouth of the Banano River (Figure 8). In this section the shoreline has experienced an erosion rate of 4,842 m²/year in the period 2005-2010, a value that increased to 6,471 m²/year between 2010-2016, which shows an increase in erosion dynamics.

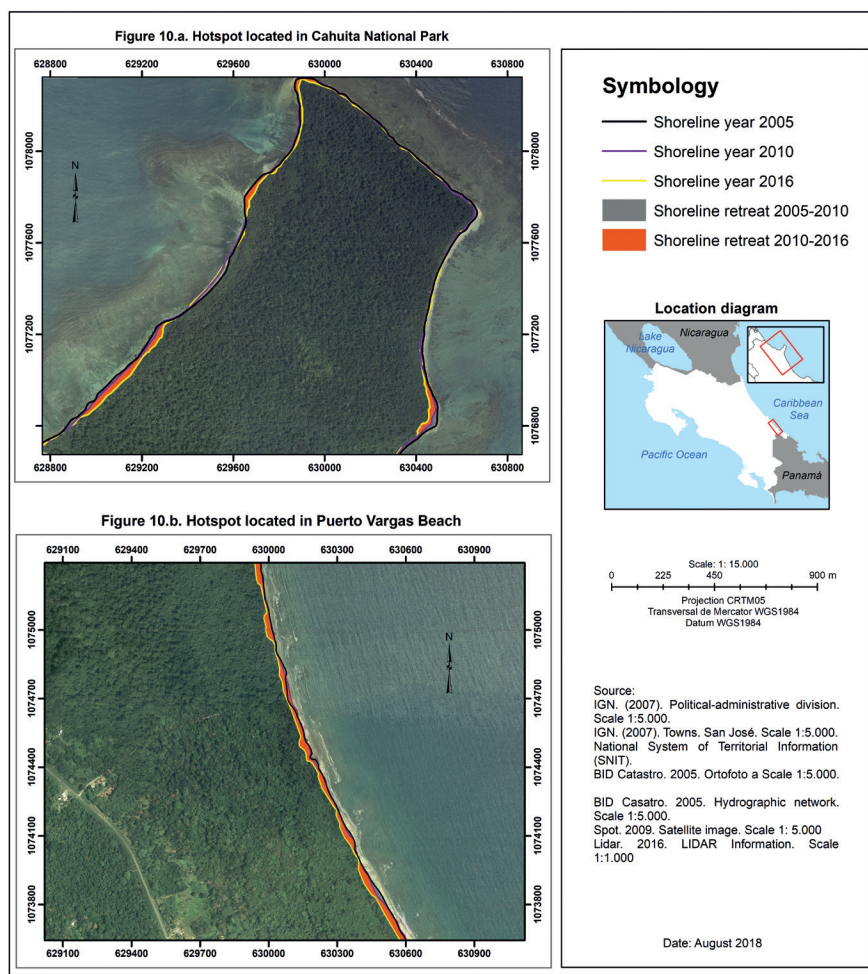
Figure 10. Hotspots located around the Cahuita National Park area

The first point of accelerated erosion is found within Cahuita National Park, specifically in the area known as Cahuita (Figure 10.a). In this area of the park, shoreline retreat for the period 2005-2010 was 1,300 m²/year, a value that increased to 4,598 m²/year for the 2010-2016 period. These values show that the erosion rate tripled in the most recent period.

The other hotspot is in the other area of Punta Cahuita, known as Puerto Vargas (Figure 10.b). At this point the erosion rate was 2,480 m²/year in the period 2005-2010 reaching 9,510 m²/year in 2010-2016. In this

area, as in Cahuita National Park, the last period showed a triple increase relative to the 2005-2010. Heavy erosion is quite evident along the access trail to old Puerto Vargas.

In the previous points, it is notable that the presence of an extensive current reef, considered the largest in Costa Rica (Cortés *et al.*, 2010), does not seem to represent a natural barrier against erosion, despite harboring the coast in front of the critical points of this land section. It is possible

that local variations in depth, together with the presence of rocky channels, could create wave refractions and a redistribution of drift currents thus partially explaining the presence of these two erosion hotspots.

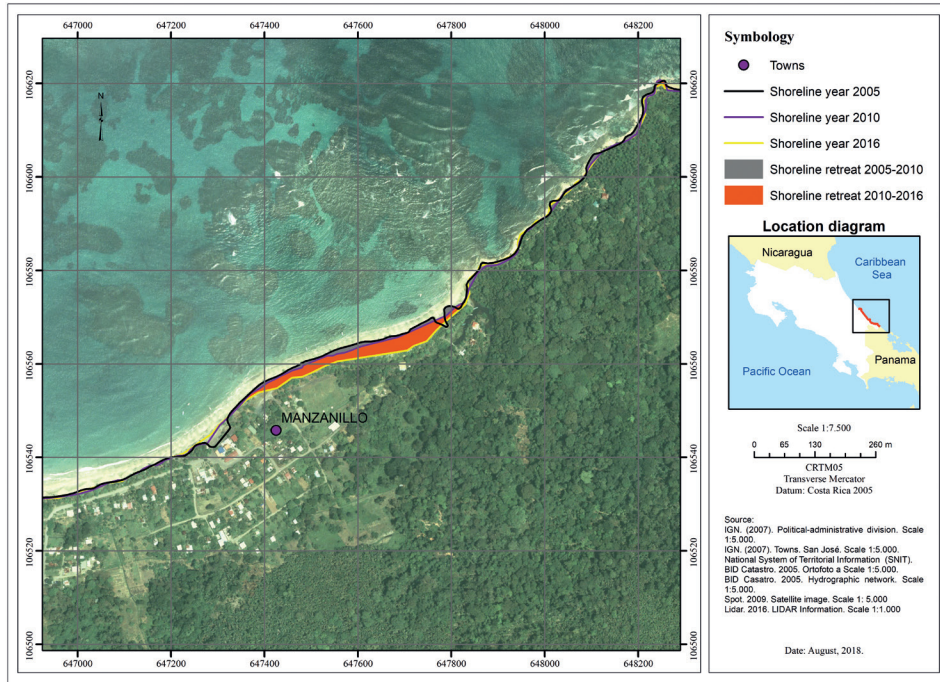
Figure 11. Erosion hotspot located in the vicinity of the town of Manzanillo.

Manzanillo Beach is located in front of a reef that is considered by Cortés *et al.*, (2010) as an incipient crest of algae; according to these authors, as of 2003, the life coral formation covered only 7% of the extension of the beach. As in the case of the previously described sectors, the erosion rate of the beach was moderate in the period 2005-2010 reaching a value of 745 m²/year, which increased to 1,678 m²/year between 2010-2016; this represents a two-fold increase (Figure 11).

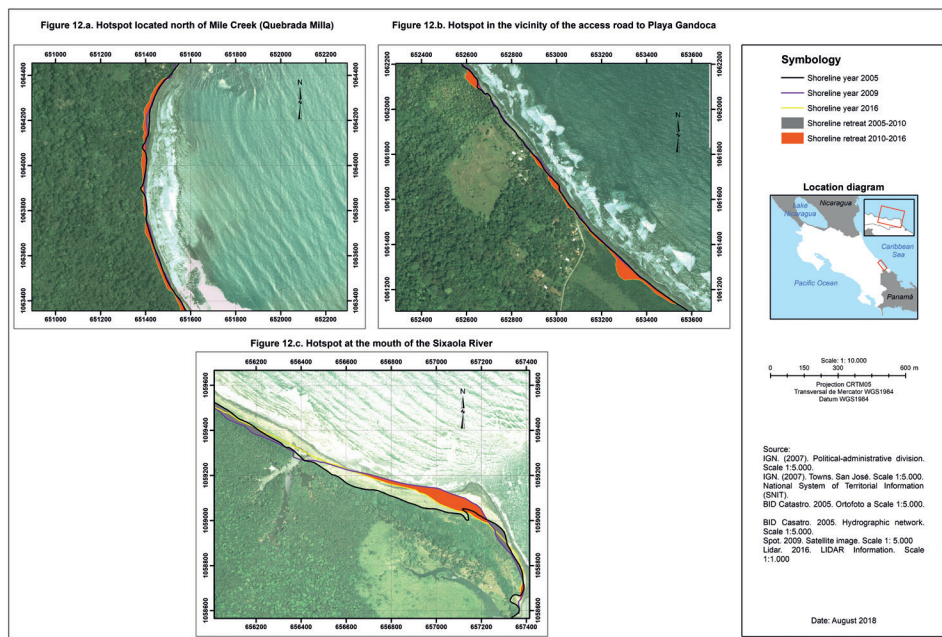
Figure 12. Hotspots located in the Punta Mona-Sixaola sector

Three hotspots have been discovered in this sector, the first in Mile Creek, a locality also known as Quebrada Milla (Figure 12.a). In this case, the section of shoreline retreat extends along the beach. For the period 2005-2010, the erosion rate was 626 m²/year, a value that increased more than seven-fold in the second period from 2010-2016, reaching a value of 4,865 m²/year.

The second hotspot is found near the access road to Gandoca Beach (Figure 12.b). It is a small area where, as in the previous case, erosion was lower for the 2005-2010 period with a rate of 1,194 m²/year that increased three times to 3,642 m²/year for the period 2010-2016.

The last section of this sector is the beach located between the Gandoca Lagoon and the Sixaola River (Fig. 12.c), in this point erosion rate reached $1,697 \text{ m}^2/\text{year}$ in the period 2005-2010 and, increased more than four-fold to $7,456 \text{ m}^2/\text{year}$ in the period 2005-2016.
