Critical beaches due to coastal erosion in the Caribbean south of Costa Rica, during the period 2005-2016

*Gustavo Barrantes-Castillo*¹
*Isabel Arozarena-Llopis*²
*Luis Fernando Sandoval-Murillo*³
*José Francisco Valverde-Calderón*⁴
Universidad Nacional, Costa Rica

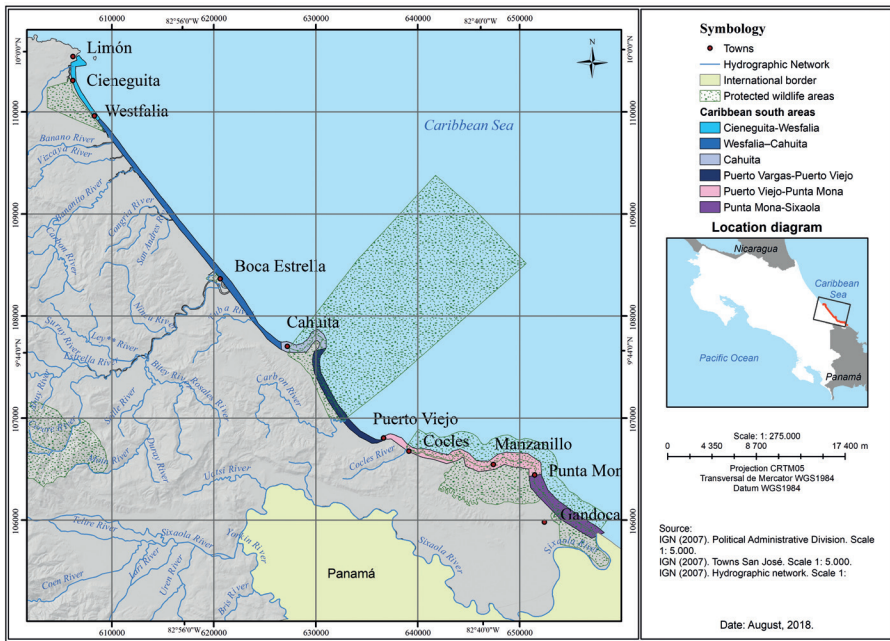
Figure 2. Beach erosion study areas in the Costa Rican Caribbean south.

To facilitate the interpretation of the obtained results, the study area was divided into six sectors according to the configuration of the coast (Figure 2), namely:

- **Cieneguita-Westfalia:** sector located at the northwest end, characterized by possessing an extensive beach with a slight concavity pointing north opening to the Caribbean Sea, mainly in the sector closest to the rocky promontory where the city of Limón is located. Cieneguita Beach has a jetty approaching the middle of the beach.

- **Westfalia-Cahuita:** this sector appears as a rectilinear coast having in its surrounding the presence of the mouths of important fluvial systems and wetlands (estuaries).

- **Cahuita:** small peninsular sector having two sections where the rocky reef platform is interspersed by a sandy beach (Cahuitas's Blanca Beach); on the smallest section of the platform sits the town bearing the same name (Spanish "Playa Blanca"), and on the other a section of land called Punta Cahuita. Both Blanca Beach and Punta Cahuita are part of a wildlife protected area (Cahuita National Park). Among the current main features of the park is the presence of an important coral reef.

- **Puerto Vargas-Puerto Viejo:** this corresponds to a straight to slightly concave shoreline sector spanning from the old berth town of Puerto Vargas to the town of Puerto Viejo; shoreline concavity opening to the Caribbean Sea. The continuity of this shoreline is only interrupted by the mouth of the Carbón River.

- **Puerto Viejo-Punta Mona:** this sector is comprised of relatively short and pocket beaches interspersed with ledges, rocky promontories and outcrops of the Pleistocene reef formations in the form of terraces.
- **Punta Mona-Sixaola:** rectilinear shoreline interrupted by ancient estuaries and wetlands; only the initial section of Punta Mona is rocky. It ends at the southern tip of Costa Rica, at the mouth of the Sixaola River which serves as the Costa Rica-Panamá international border.

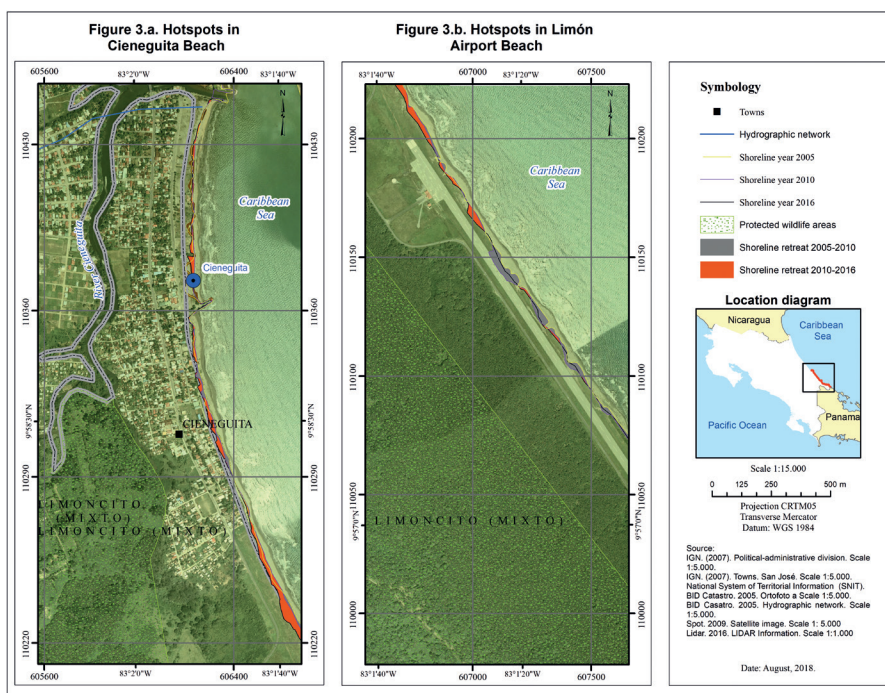
Figure 3.a. Hotspots in Cieneguita Beach.
Figure 3.b. Hotspots in Limón Airport Beach.

The sector between the jetty and the airport runway is considered an erosion hotspot registering a retreat rate of 1,430 m²/year for the 2005-2010 period and 3,936 m²/year for 2010-2016. According to these data, the retreat rate almost tripled in the second period (Figure 3.a). The above points to an apparent erosion process indeed confirmed by field inspection, during which it was also evidenced the resulting deterioration of public infrastructure and the ongoing maintenance works to contain further down-grade by placement of stones and wire meshing (Figures 4 and 5).

In the northern section of this sector is an urbanized area called Barrio Cieneguita, officially called the Cristóbal Colón sector, and to the south, the Limón Airport (Figure 3.b). The Cieneguita-Westfalia sector is

Another erosion hotspot is near the airport (Figure 3.b). For the period 2005-2010, the erosion rate of this sector was 8,801 m²/year and, for the period 2010-2016, it decreased to 1,599 m²/year. To the south of the airport there is a wetland characterized by the presence of small elongated lakes interconnected by channels that drain before reaching the town of Westfalia, thus suggesting an alteration of part of the Cieneguita wetland. The erosion of the beach has affected the asphalt layer of the runway; for its protection, rock and wire mesh covering has been installed (Figure 6).

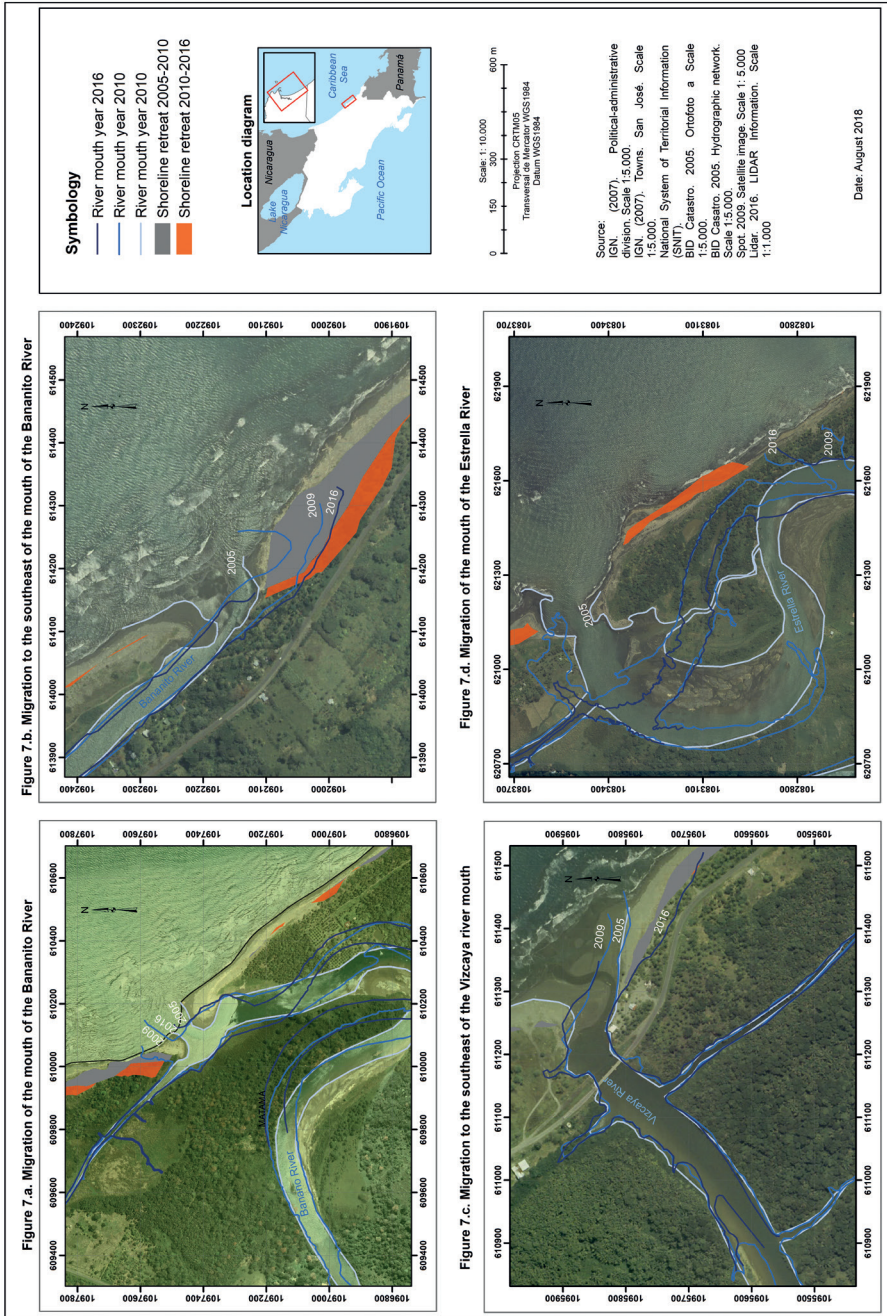
Figure 7. Coastal erosion and migration of river mouths in the Westfalia-Cahuita sector

This is a sector with extensive beaches interspersed with the mouths of important river systems (Figure 2). The littoral dynamic manifests itself in drastic changes in the shape of the shoreline, mainly due to the migration of the mouths. In this sector, the changes in the mouth of the Banano River stand out (Figure 7.a, top left) as causing the local retreat of the shoreline associated with the erosion of the left margin of the mouth and the accumulation of sediments on the right margin. Other river mouths causing significant shoreline changes are those of the Vizcaya River, Bananito River and La Estrella River (Figure 7.b, 7.c and 7.d, respectively).

Another critical point of erosion was located at the mouth of the Bananito River (Figure 7.a) where, as in the previous cases, it is related to the migration of the river course. In this case, the proximity of the shoreline with the road threatens the integrity of the main road that gives access to the rest of the region (figure 9). The erosion rate at this point is $2,817 \text{ m}^2/\text{year}$ in the period 2005-2010 and $2,793 \text{ m}^2/\text{year}$ between 2010-2016, which indicates that the rate remains similar between the two periods.

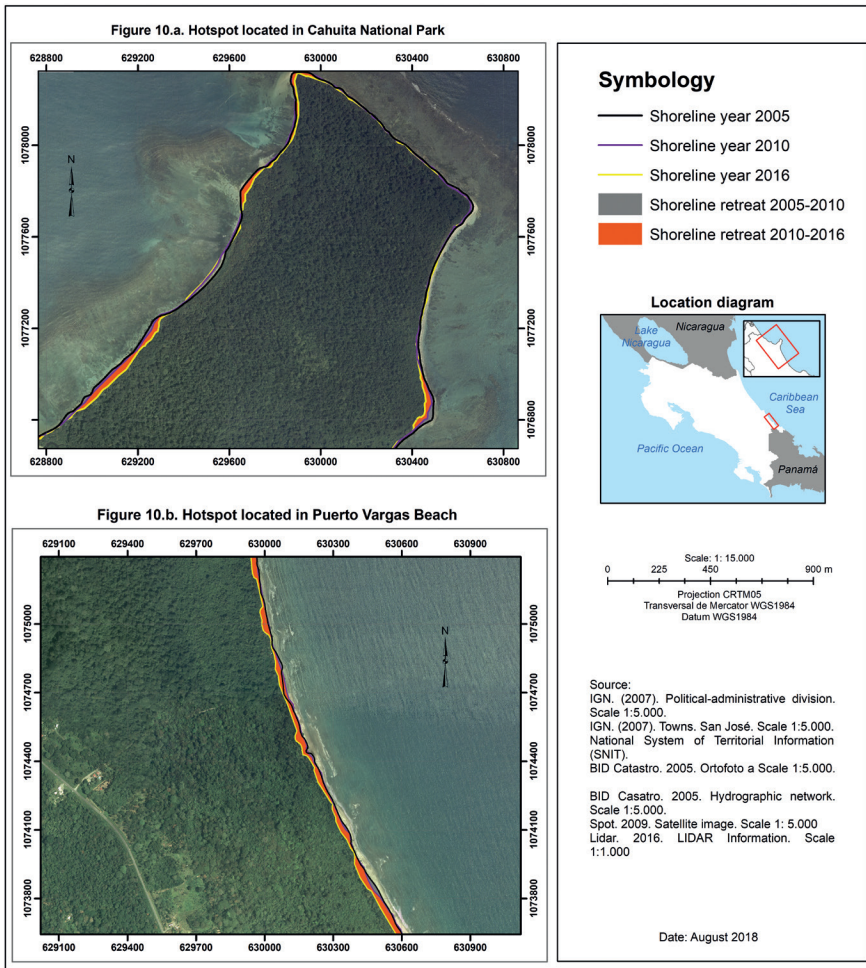
Figure 10. Hotspots located around the Cahuita National Park area

The first point of accelerated erosion is found within Cahuita National Park, specifically in the area known as Cahuita (Figure 10.a). In this area of the park, shoreline retreat for the period 2005-2010 was 1,300 m²/year, a value that increased to 4,598 m²/year for the 2010-2016 period. These values show that the erosion rate tripled in the most recent period.

The other hotspot is in the other area of Punta Cahuita, known as Puerto Vargas (Figure 10.b). At this point the erosion rate was 2,480 m²/year in the period 2005-2010 reaching 9,510 m²/year in 2010-2016. In this

area, as in Cahuita National Park, the last period showed a triple increase relative to the 2005-2010. Heavy erosion is quite evident along the access trail to old Puerto Vargas.

In the previous points, it is notable that the presence of an extensive current reef, considered the largest in Costa Rica (Cortés *et al.*, 2010), does not seem to represent a natural barrier against erosion, despite harboring the coast in front of the critical points of this land section. It is possible

that local variations in depth, together with the presence of rocky channels, could create wave refractions and a redistribution of drift currents thus partially explaining the presence of these two erosion hotspots.

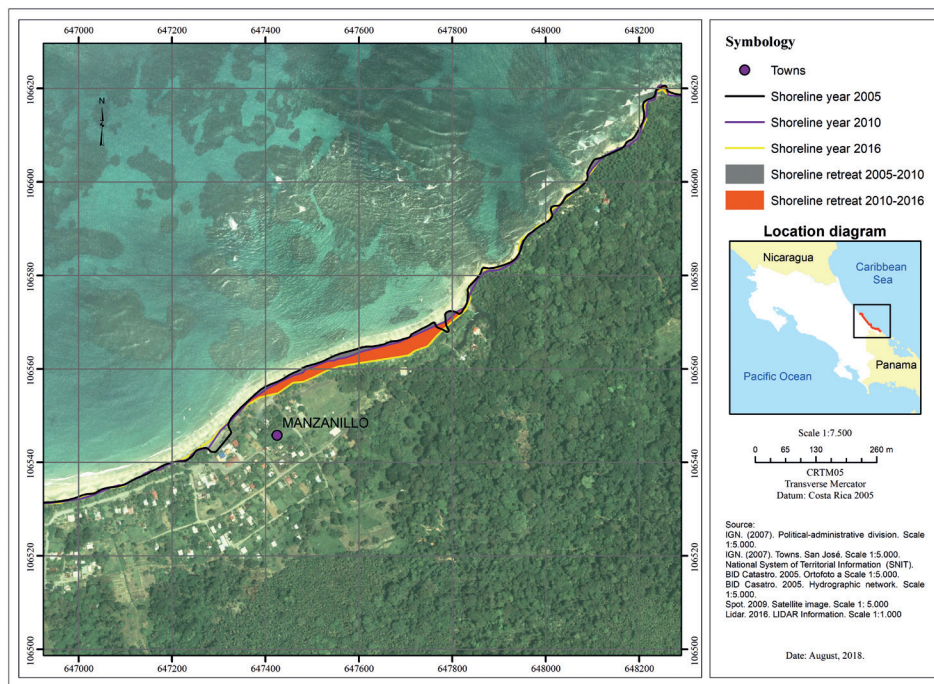
Figure 11. Erosion hotspot located in the vicinity of the town of Manzanillo.

Manzanillo Beach is located in front of a reef that is considered by Cortés *et al.*, (2010) as an incipient crest of algae; according to these authors, as of 2003, the life coral formation covered only 7% of the extension of the beach. As in the case of the previously described sectors, the erosion rate of the beach was moderate in the period 2005-2010 reaching a value of 745 m²/year, which increased to 1,678 m²/year between 2010-2016; this represents a two-fold increase (Figure 11).

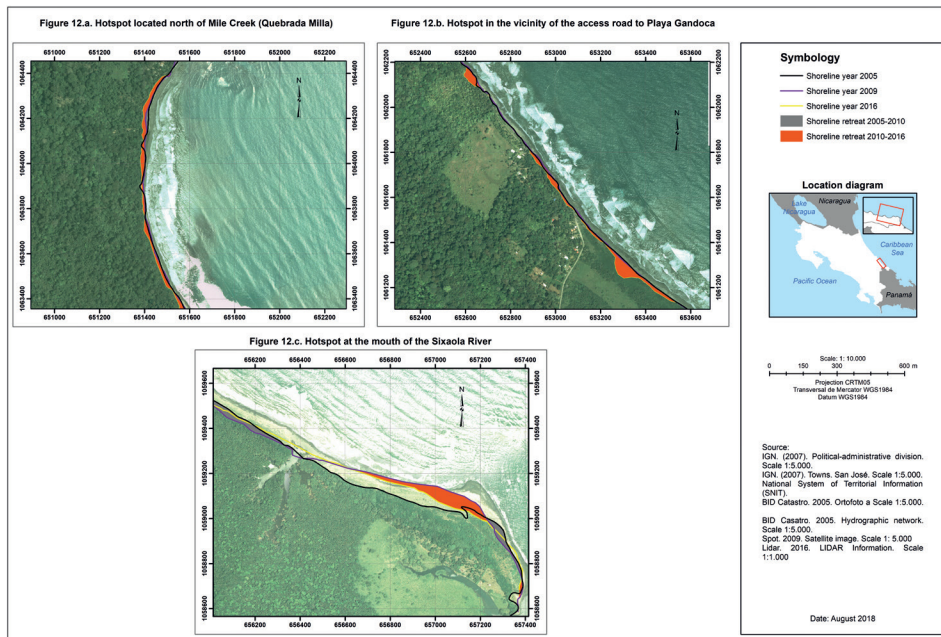
Figure 12. Hotspots located in the Punta Mona-Sixaola sector

Three hotspots have been discovered in this sector, the first in Mile Creek, a locality also known as Quebrada Milla (Figure 12.a). In this case, the section of shoreline retreat extends along the beach. For the period 2005-2010, the erosion rate was $626 \text{ m}^2/\text{year}$, a value that increased more than seven-fold in the second period from 2010-2016, reaching a value of $4,865 \text{ m}^2/\text{year}$.

The second hotspot is found near the access road to Gandoca Beach (Figure 12.b). It is a small area where, as in the previous case, erosion was lower for the 2005-2010 period with a rate of $1,194 \text{ m}^2/\text{year}$ that increased three times to $3,642 \text{ m}^2/\text{year}$ for the period 2010-2016.

The last section of this sector is the beach located between the Gandoca Lagoon and the Sixaola River (Fig. 12.c), in this point erosion rate reached 1,697 m²/year in the period 2005-2010 and, increased more than four-fold to 7,456 m²/year in the period 2005-2016.
