## Historical and geospatial reconstruction of a sector of the alternative route of the railway to the Atlantic (years 1871-1873), called: "Fajardo line", in a geographical area associated with the valleys of Orosi and Ujarrás, Cartago, Costa Rica

*Iván J. Sanabria-Coto<sup>1</sup>*

*Maureen A. Bonilla-Hidalgo<sup>2</sup>*

*Adolfo Quesada-Román<sup>3</sup>*

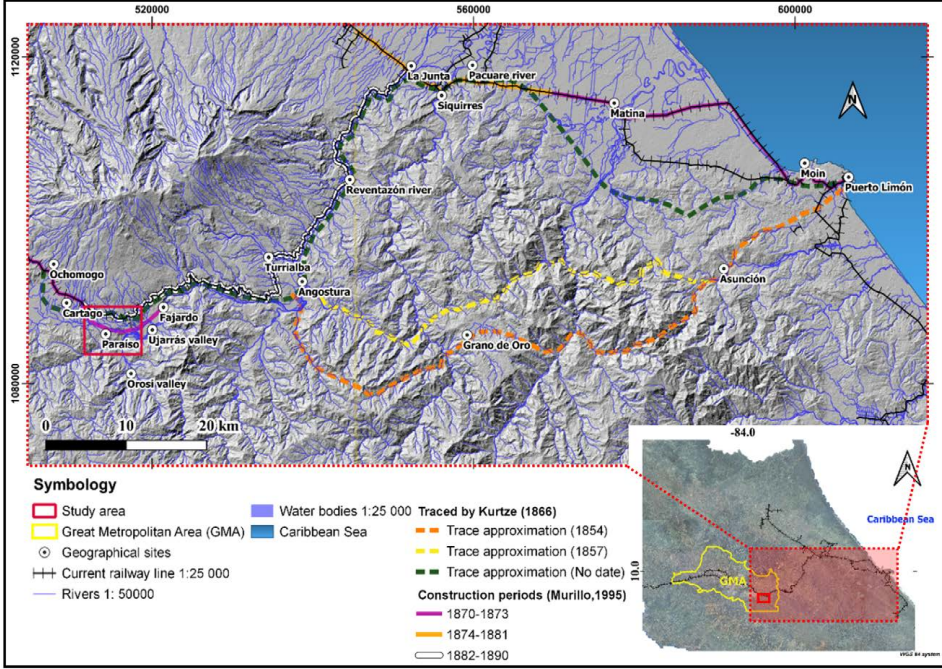
**Figure 3.** Interpretation map, in CRTM05 coordinates, of the routes proposed by Kurtze (1866) and of the subsequent construction stages (Murillo, 1995).

In the previous figure three approximations of the proposed routes to the Atlantic region of the country are observed, denominated as: “Line Survey”, with dates: 1854 (in orange), 1857 (in yellow) and undated (in green), the last route bears the greatest resemblance to the current route; however, within this proposal by Kurtze (1866), the railway route was located on the right bank of the Reventazón River, contrary to the current definitive route (left margin).

Further, within this same area, shown in the map of figure 3, [Murillo \(1995\)](#) manages to differentiate geographically the subsequent construction periods of the railway to the Atlantic.

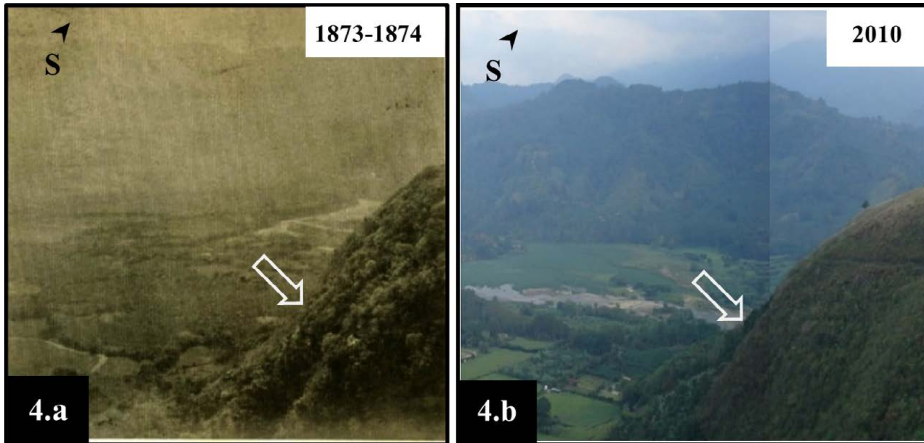
**Figure 4.** View of the approximate sector (arrows) of construction of the railway line at the base of the “Santa Lucia hill/volcano” (Ujarrás) during the years 1873-1874 (4.a) and 2010 (4.b)

Both photographs (Figures 4.a and 4.b) were taken from the vicinity of the current Mirador de Ujarrás (translated as Ujarrás Viewpoint) operated by the Costa Rican Tourism Institute (ICT) (Figure 1), where it is possible, according to Sanabria-Coto and Bonilla-Hidalgo (2021), to appreciate the so-called “Santa Lucía hill/volcano” also known as: “Picacho”. The arrows (in white) indicate, approximately, the sector which shows evidence that construction work was carried out for the railway route.

In historical photographs obtained from SINABI (2020) the high degree of vegetation cover existing in the Ujarrás Valley is visualized, for the years 1873-1874 (Figure 4.a) as well as for the year 2010 (Figure 4.b), which allows to understand the degree of natural complexity of the study area, specifically to the west of the Ujarrás Valley, through the so-called "Santa Lucía hill/volcano" (Sanabria-Coto & Bonilla-Hidalgo, 2021, p. 32).

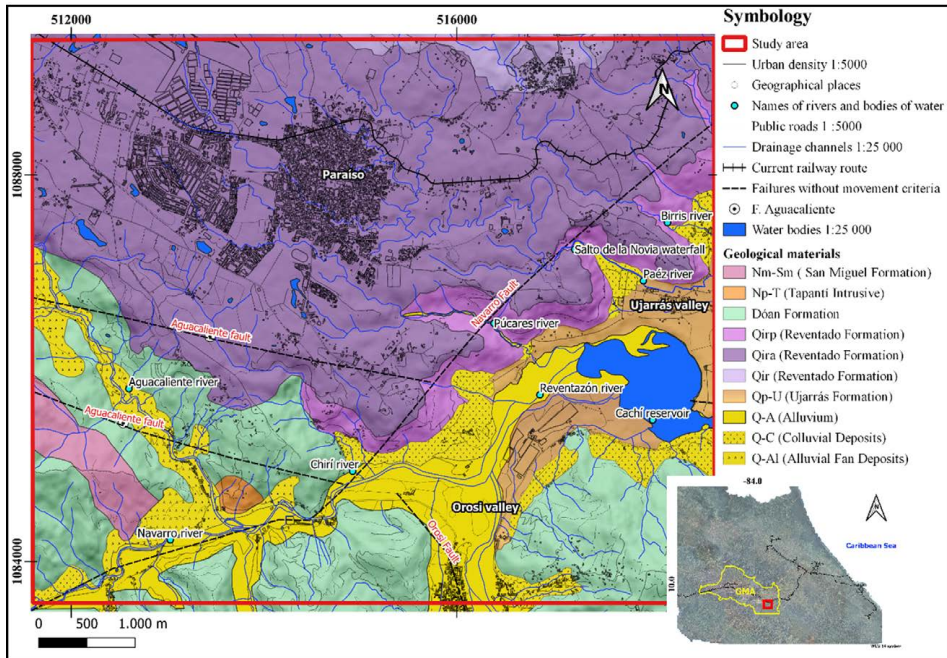
**Figure 5.** Geological map of the study area in CRTM05 coordinates

In addition, despite the good geomechanical conditions identified (Table 1), but nonetheless difficult to manage with the equipment of the moment, there are other physiographic elements such as tectonism linked to the Navarro fault trace (Figure 5), which implied higher levels of

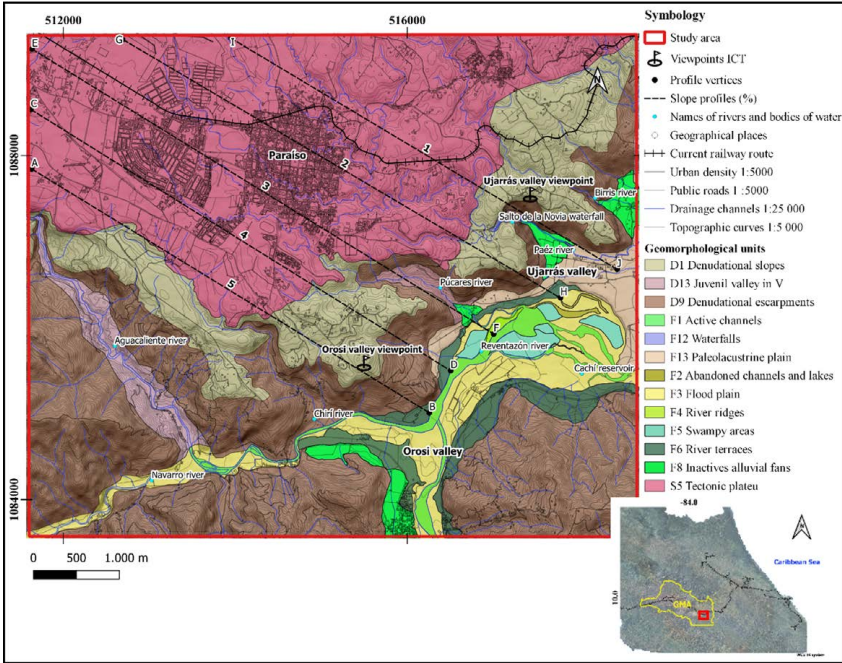
**Figure 6.** Geomorphological map of the study area in CRTM05 coordinates.

fracturing. In addition to the geomorphological characteristics, slope (Figure 6) and hydric conditions, collectively made difficult the construction of terraces with minimum horizontal gauges or berms directly in the volcanic rocks, for the future passage of the railway, in the volcanic rock hillsides south of the supposed Santa Lucía hill/volcano (Figures 1 and 10).

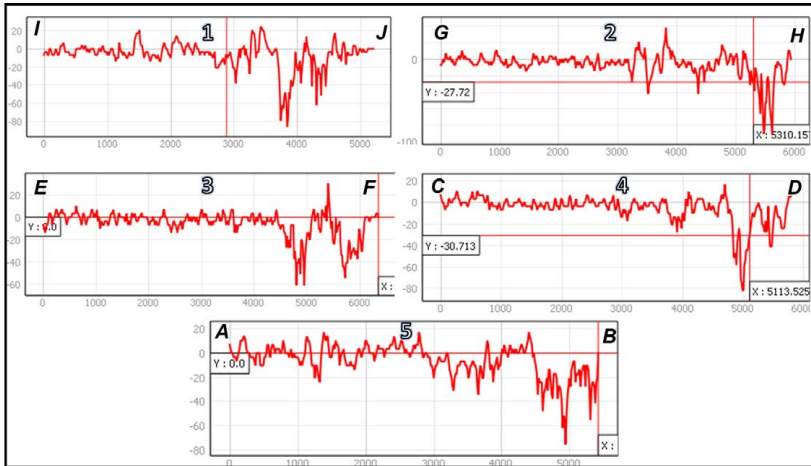
percentages of topographic relief were identified in the direction heading from the city of Cartago towards the Reventazón River in Ujarrás (north-west-southeast), being profile N°3, in the vicinity of the Púcares River valley, the one showing the lowest slope percentages (Figure 7).

**Figure 7.** Profiles with slope percentages (1-5) located on the map of Figure 6.

In summary, for evidence area III, the geomorphological characteristics (profile 1 in Figure 7) were used to their maximum potential, to achieve a relative transition in the construction of the railway route from the abrupt and superior topographic relief to the Ujarrás Valley which is characterized by denudational escarpments (D9), specifically on the slopes of the supposed Santa Lucía hill/volcano and up to their contact with the bottom of the Ujarrás Valley (Figure 6).

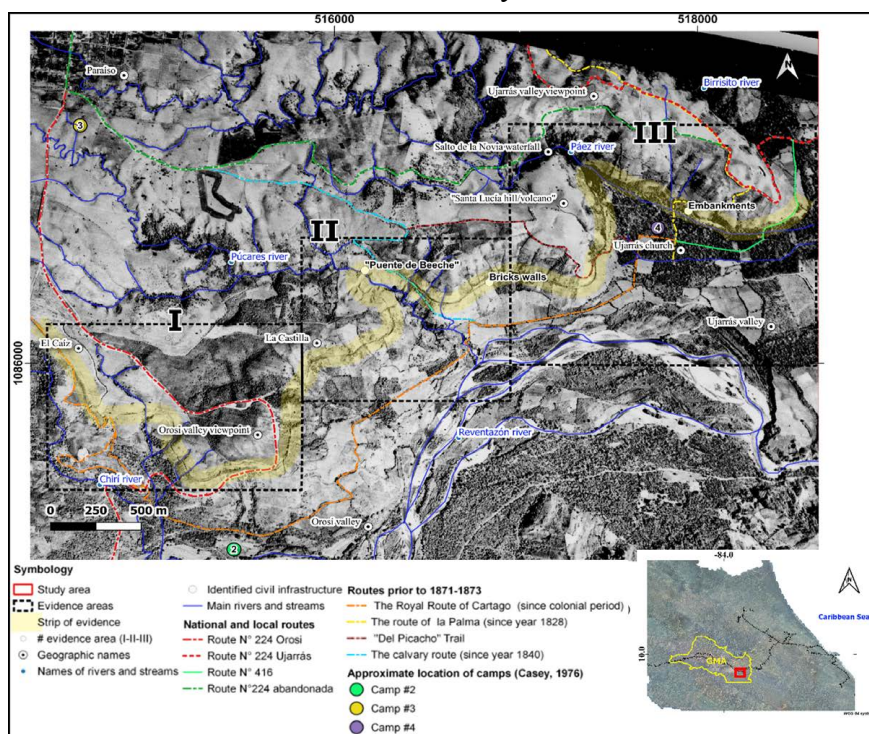
**Figure 8.** Location of three evidence areas on the construction of the railway during the years 1871-1873 of previous and subsequent routes within the study area

On the other hand, on the map in Figure 8, three main geographical areas with vestiges of construction works and/or associated inferred evidence were also recognized, namely: evidence area I, north of the Orosi Valley in the vicinity of the ICT's overlook, followed by evidence area II, located between La Castilla and the entire Púcares river valley; finally, evidence area III covers the west and the Ujarrás Valley.

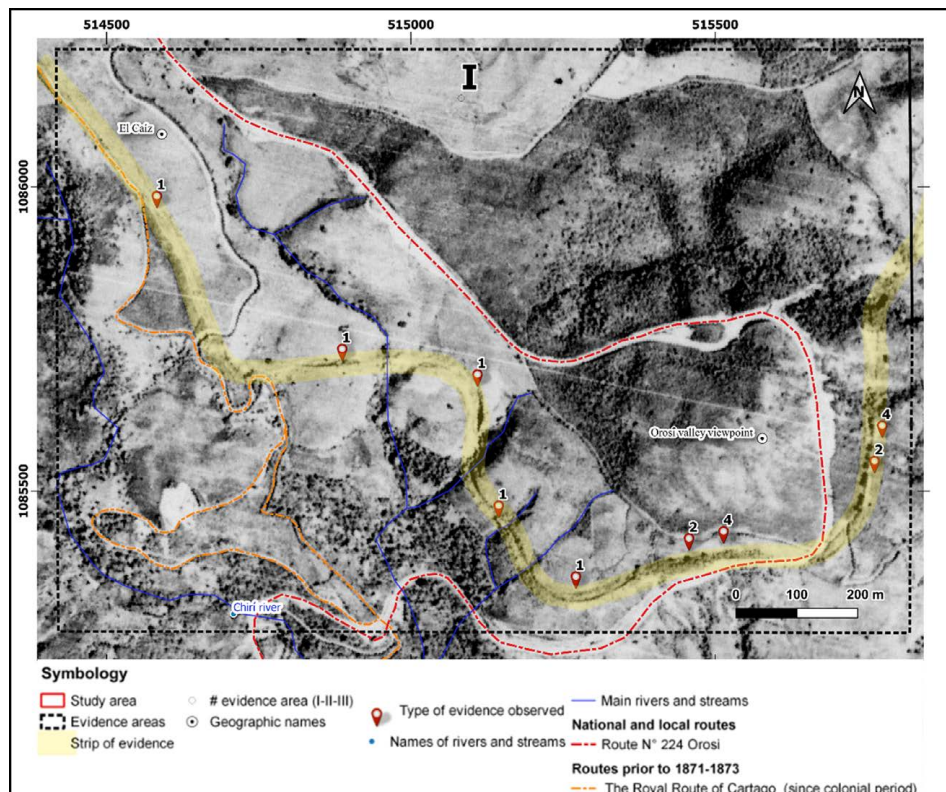
as well as the evidence inferred through GIS, as a consequence of the alteration or adaptation of the characteristics of the physiographic context. For the latter, the previously described evidence classification was used, starting with evidence area I, southwest of the study area (Figure 9).

**Figure 9.** Evidence Area I, evidence numbering (1-7) within the study area is as described above.

According to [Sánchez \(2017\)](#), the line constructed between 1871-1873 departed from the Ujarrás Valley westbound, through the sector known as La Castilla, and continued through the Caíz sector until connecting with the section constructed to reach to Cartago; this last mentioned sector (Caíz) agrees geospatially with the first evidence area (I) (Figures 8 and 9).

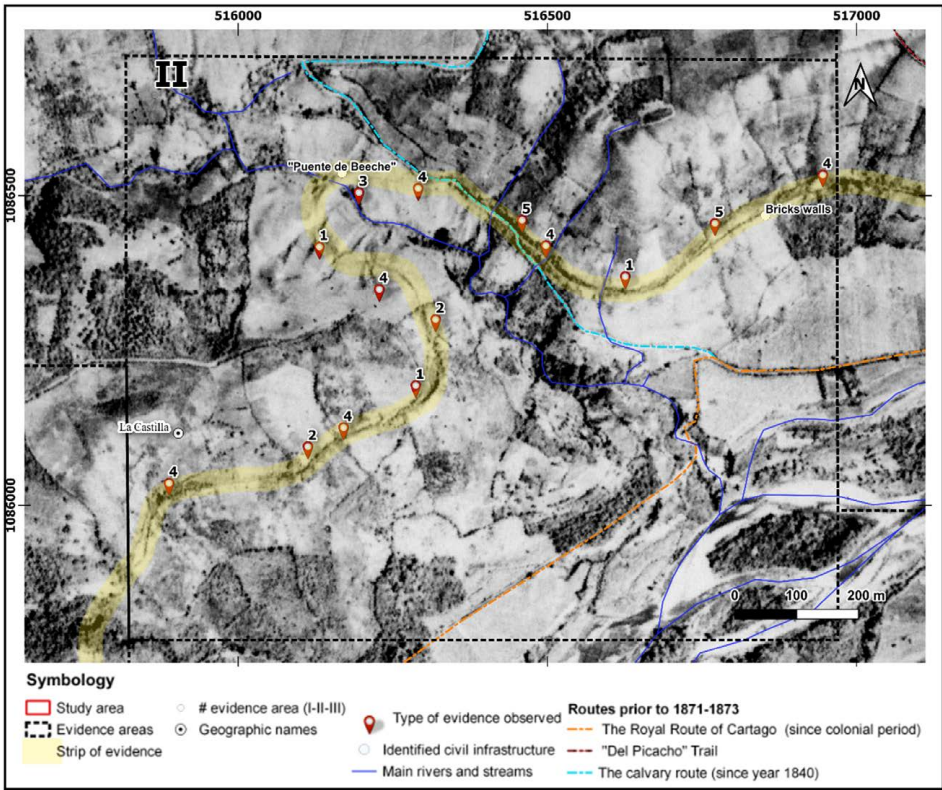
On the other hand, it should be noted that in evidence area II, in addition to the identification through GIS of adaptive elements of ground work (Figure 10), there are physical construction vestiges (civil works) such as: bridges, culvert passages, and retaining walls in masonry, being complementary and necessary elements for a better adaptation of the route to the physiographic context of the study area, an example of this is the so-called "Puente de Beeche" over the Púcares River.

**Figure 10.** Evidence area II, evidence numbering (1-7) within the study area is as described above

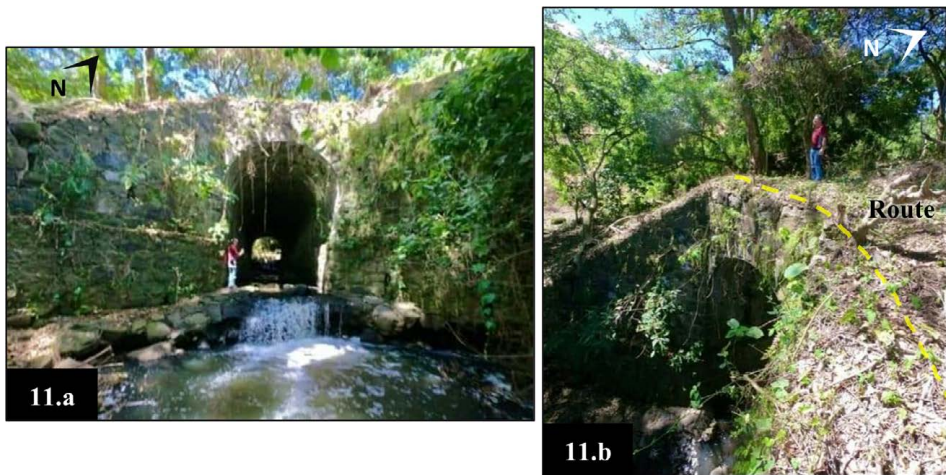
The latter is exemplified in figures 11.a and 11.b, with a view of the "Puente de Bechee" built over the Púcares River, which, according to S. Barquero, has the year of construction engraved on the rock: 1872 (personal communication, September 19, 2021).

**Figure 11.** Site view of the bridge *Puente de Bechee* built in the study area, over the Púcares River (1.a), for the railway route overpass (11.b).

For Sánchez (2017) the bridge "Puente de Beeche" is built entirely with stone ashlar that occupy the entire wall, being a construction of a semicircular arch, with a pipe vault followed by length of 30 m having a

In the third division, most of the work activities of skilled workers were devoted to the construction of bridges. It became necessary to hire several stonemasons responsible for providing the masons and laborers with granite blocks necessary for creating a good foundation of the bridges (Casey, 1976, p. 313).

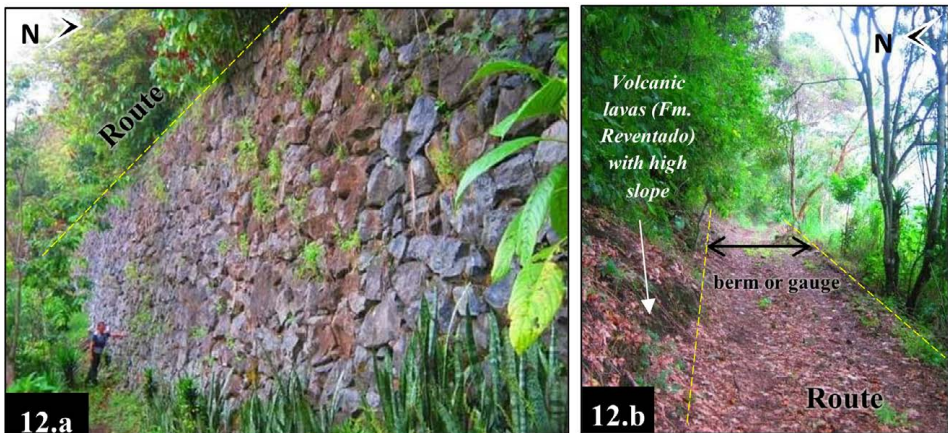
The constructive solution to the previous problem is observed in the field by means of impressive and extensive retaining walls or lateral support that extend for tens of meters with minimum heights of 4 to 5 meters (Figure 12.a). These walls contributed to create way for the railway route in sectors where the hillsides were made of volcanic rock and positioned almost vertically, allowing gauges or berms of 3 to 4 meters in length on average (Figure 12.b).

**Figure 12.** View of stone retaining (brick walls) (12.a) for the formation of berms or gauges of the railway route (12.b).

These walls were built with the same construction technique of "stone blocks" mentioned above, to support the overpass of the route. This is because, despite materials of high geomechanical competence (lava) exist in situ (Table 1), it is due to the high gradient of the natural slopes and fracturing (Navarro fault) that involved a difficult excavation to achieve stable and wide vertical cuts in track gauges of possible terraces or berms.

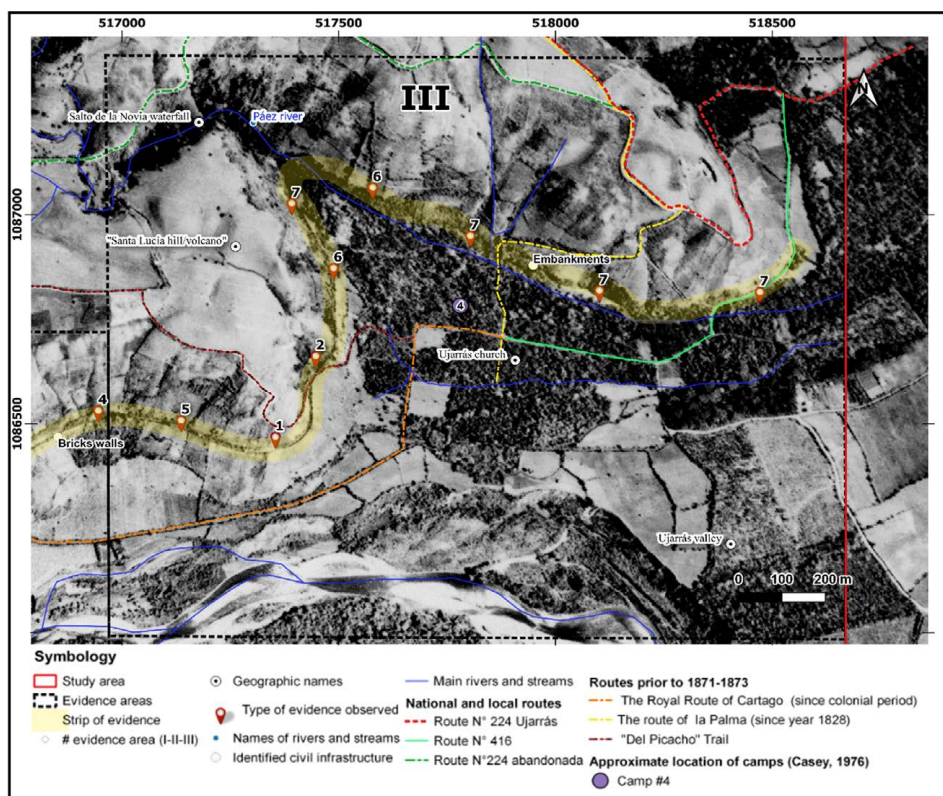
Additionally, regarding the above, Núñez (1924) points out that when starting the railway works it was initially thought to follow the southern route, enabling the plains of Ujarrás, but after realizing a moderate expenditure of capital on land filling, construction of sewers and bridges, the original idea was abandoned; today the layout of that period can still be seen in the ruins of brick walls present in evidence area III (Figures 8 and 13).

**Figure 13.** Evidence area III, evidence numbering (1-7) within the study area is as described above.

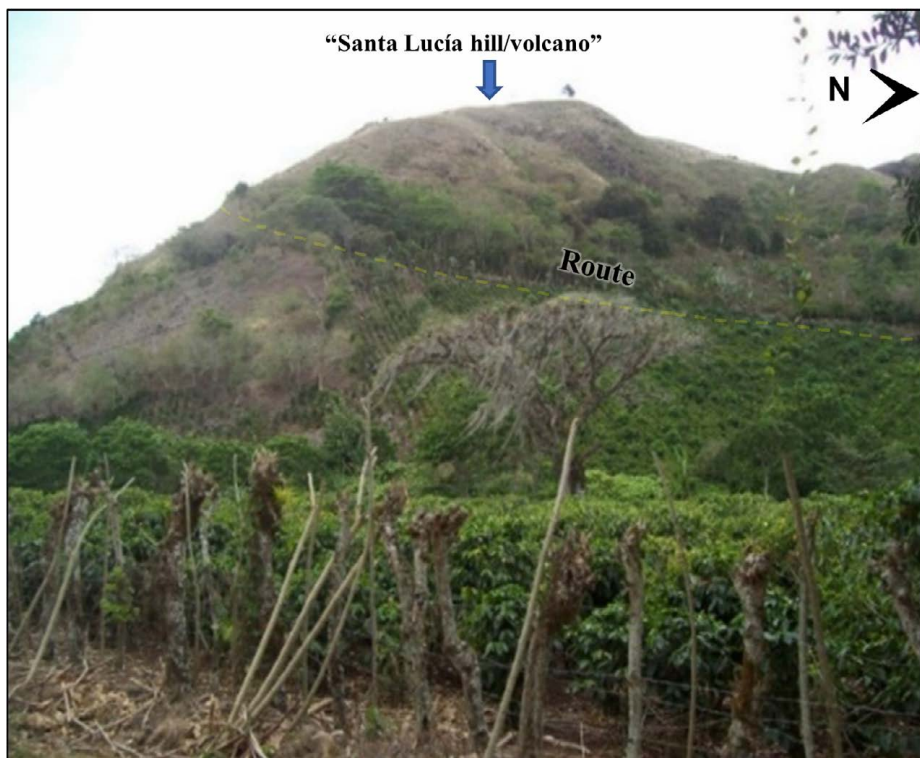
On the other hand, as indicated by Bolaños *et al.* (1993), the original section of the route from the Paraíso area continued eastwards, passing through the foothills of the Santa Lucía hills, towards the Los Novios or de la Novia waterfall or also called "Cascada Salto de la Novia", formed by the fall of the Paéz River at the bottom of the Ujarrás Valley (Figure 8), and from there the route headed towards Fajardo, where it is still possible to see the path known as "La Línea" as well as large roads, all these aspects seen in evidence area III (Figure 14).

**Figure 14.** Visualization, in the field, of cuts and formation of berms or terraces of descent/ascent on the eastern slopes of the "Santa Lucía hill/volcano"

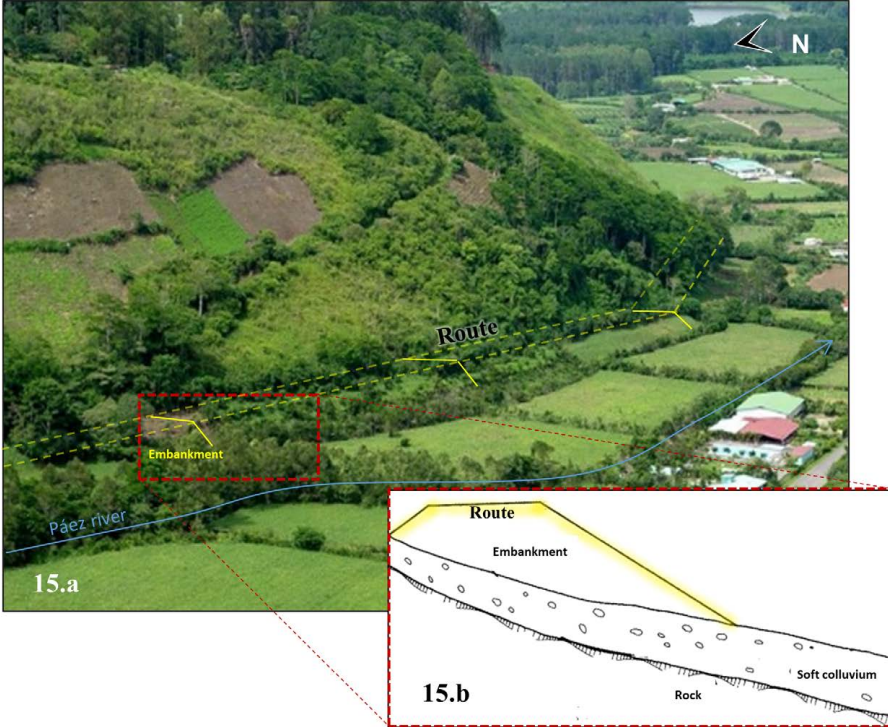
In addition, it was verified by both GIS and field observation the presence of evident cuts in the original slope and the formation of berms or horizontal terraces towards the north of the Ujarrás Valley, which are linked to the construction of extensive embankments (Figure 15.a), all as part of an adaptation to the terrain and protection of the future railway line (Figure 15.b) against the fluvial geodynamics of the valley floor.

**Figure. 15.** Transverse embankment at the foot of the slopes adjacent to the Ujarrás Valley (Figure 15.a), with a comparative diagram of its function (Figure 15.b).

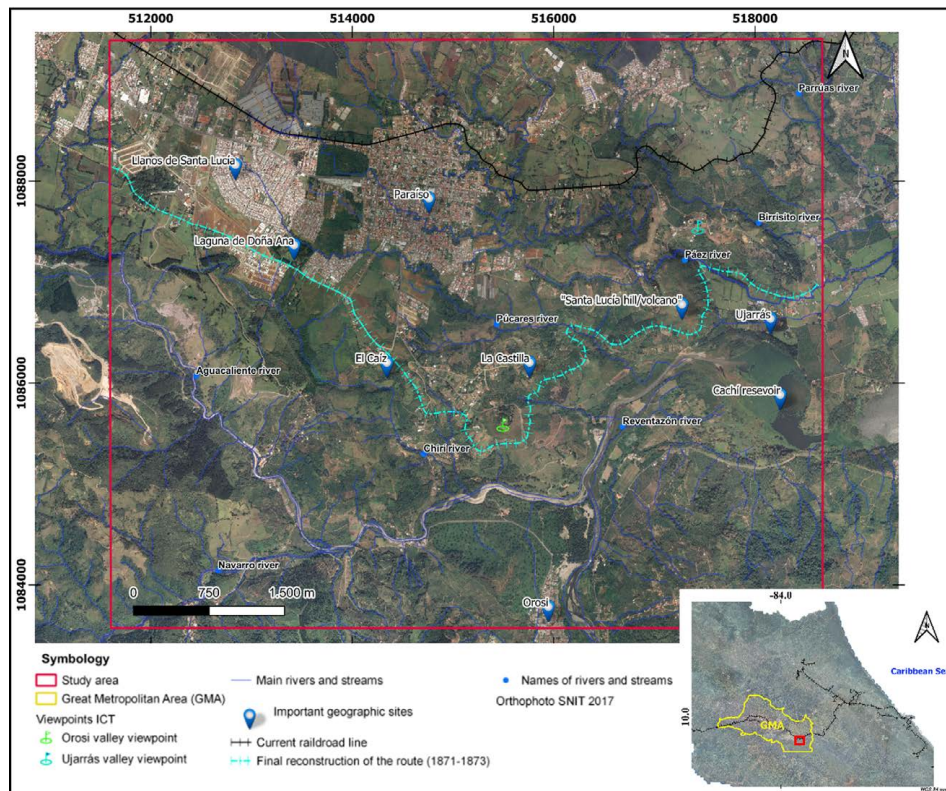
Finally, traced over orthophoto obtained from SNIT (2021) it can be appreciated the definitive geospatial location of the railway route constructed during 1871-1873 proposed in the present research as the result of the integral inclusion of all the variables related to the topographic relief, the geological conditions, geomorphological characteristics, as well as all the identified constructive physical elements (civil works) in the field; and as a consequence of the identification by means of GIS of evidence of alterations or anthropic adaptations of the terrain (Figure 16).

**Figure 16.** Comparative image between both constructed routes, the southernmost corresponds to the alternative route of 1871-1873 while the definitive route is to the north of the study area
